## Surface infiltration rates and clogging

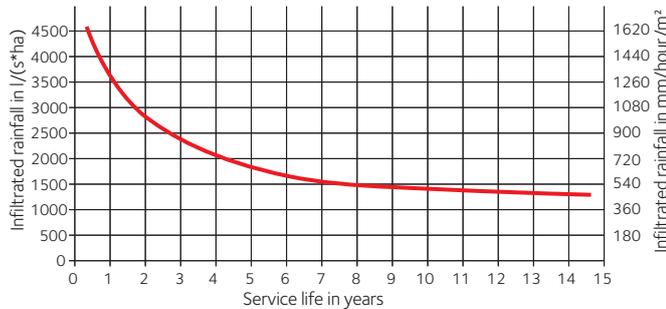
Research has demonstrated the build-up of detritus in the jointing aggregate will reduce the infiltration, but rate of reduction will decrease and stabilise over time. This effect is summarised in below.

As discussed (above), the infiltration rate of a permeable pavement will decrease due to the build-up of detritus in the jointing aggregate but stabilise with age. However, evidence suggests that infiltration rates always remain significantly higher than rainfall intensity, so, even without maintenance, there should be sufficient infiltration to accommodate rainfall events. It may be advisable to sweep occasionally but this should not be any greater than is normally undertaken on traditional pavements. However in reality, experience suggests that this is rarely carried out.

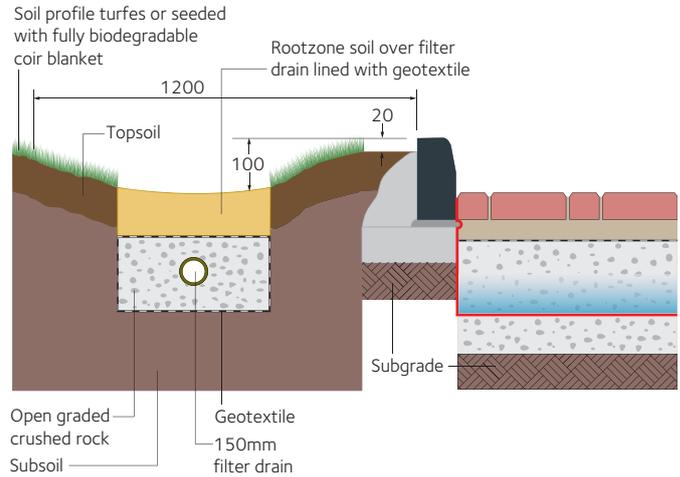
Landscaping and adjacent areas should be designed such that it does not cause soil, mulch and other materials to be washed onto the permeable surface causing clogging of the joints. A typical detail is shown in the diagram below.

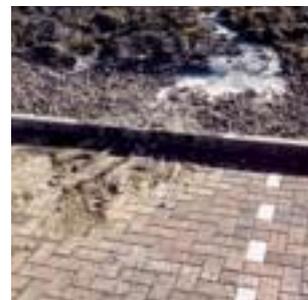
Do not store materials on the pavement that may lead to clogging.

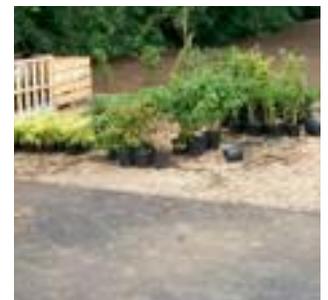
Protect the newly laid paving from contaminated run off

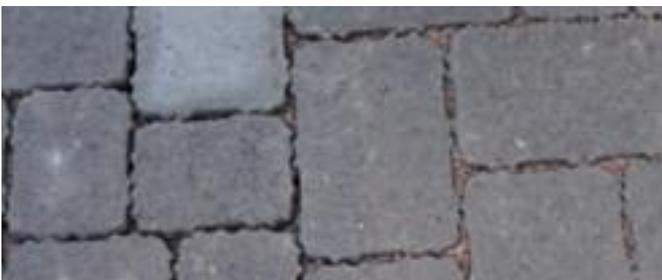
The joints on the right are full, whereas the joints on the left require topping up with new joint aggregate.

To maintain structural integrity it is important to ensure that all the joints are full with the correct permeable aggregate. It may be necessary, particularly in the early life of the pavement, to top up the joints with permeable jointing aggregate.
