# Meltone Kerb CS1

## Technical Data Sheet

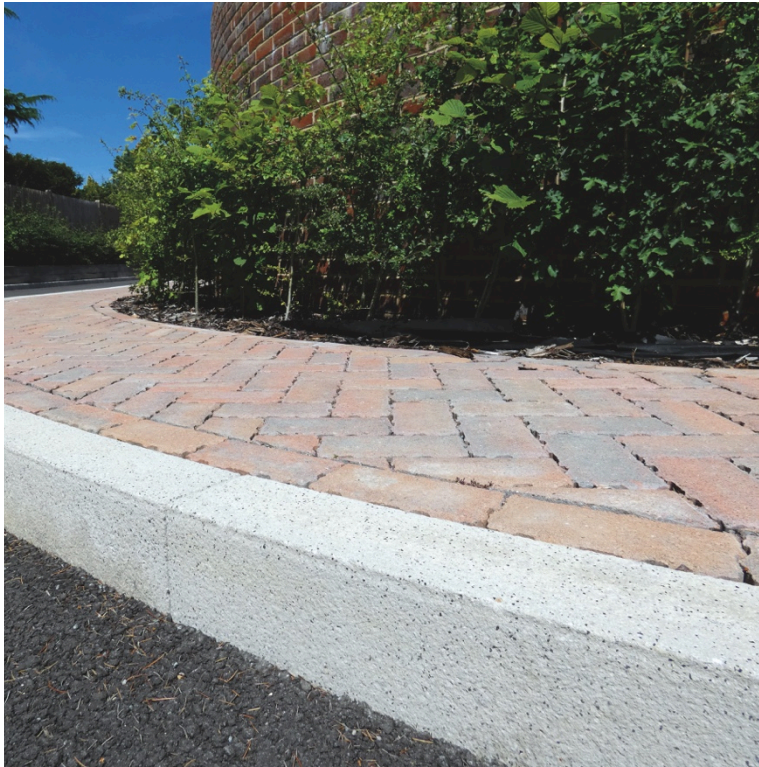
Black Fleck

Flat Top Edging

CS1

Brett Meltone wet-pressed kerbs feature a silver-grey granite finish and finely textured surface perfectly complementing both the Meltone Flag paving range and the Invicta Block Paving range.
